Inspection Report

Minerals Regulatory Program

Mine Name: Strawberry River	Permit Number: S/013/0008
Operator Name: Rock & Stone LLC	Inspection Date: July 29, 2009
Inspector(s): L Heppler	Time: 6:00 pm
Other Participants: none	Mine Status: ACT

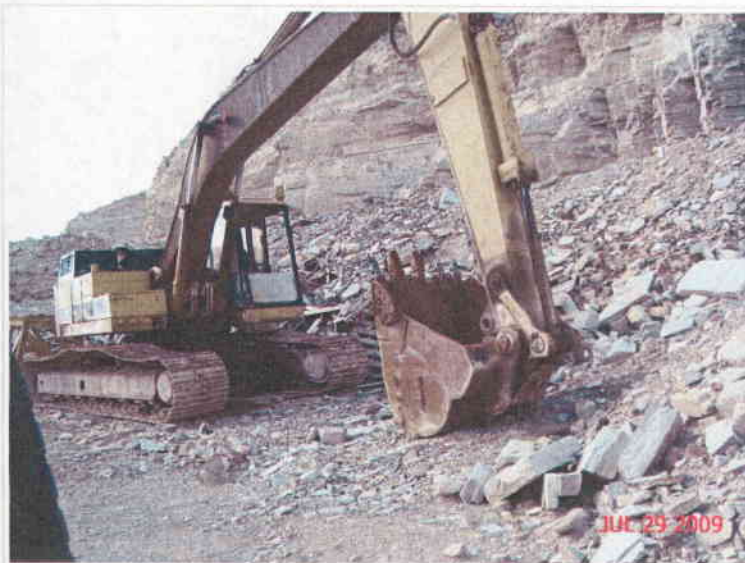
Inspection Summary: Every effort should be made to salvage topsoil from the site prior to mining. Five (5) large pieces of equipment on site have rusty buckets, blades and tracks; it is not clear when was the last time the mine was operating. Vegetation has not been established. Product storage area is limited; the majority of the palletted stone has been moved off site. Trash at the site needs to be removed. Area south of the road has not been properly regraded or revegetated. Highwall of the mine site is consistent with natural environment to the east of the mine.

Note – Rusty tracks and buckets
